Manhole Inspection Summary

Manhole # S53M__047MH

Insp Date: **10/30/08 2:20 PM**

Location Address: **3026 dillon st**

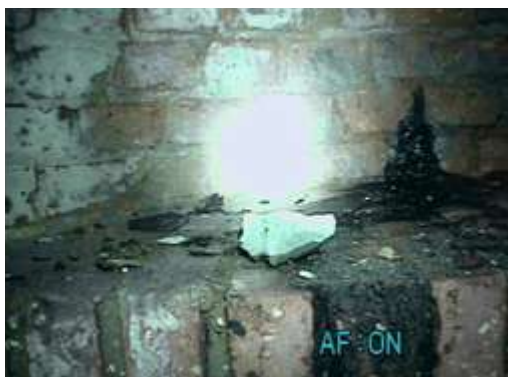
Miscellaneous

bench debris

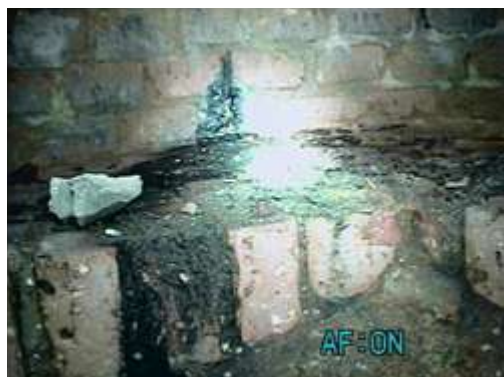
Defect 4

Infiltration: ☐ None ☐ Joint ☐ Cracks ☐ Mortar ☐ Roots ☒ **Wall**

barrel infiltration

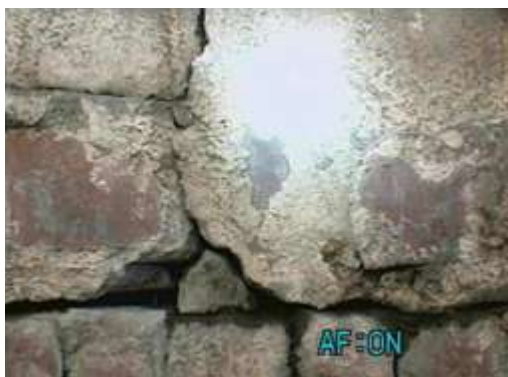
Defect 3

Condition: ☐ Sound ☒ **Cracked** ☐ Root Intrusion ☒ **Loose Brick** ☐ Deteriorated

frame adj

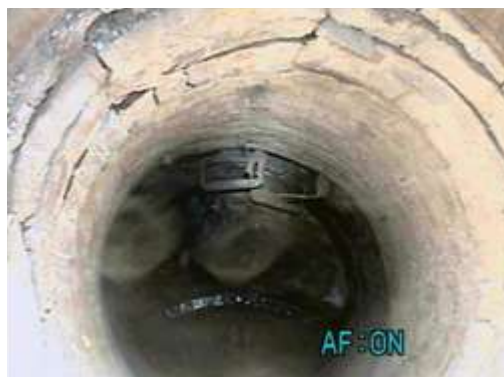
Defect 2

Steps Count: **6** Missing: **4** ☒ **Corroded**

missing steps

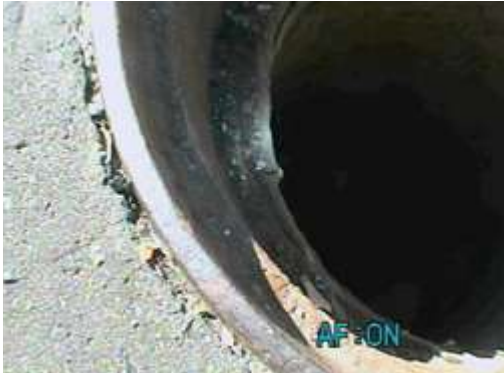
Defect 1

Frame Offset: **2.5** (in.) Condition: ☒ Sound ☐ Cracked ☐ Leaks

offset

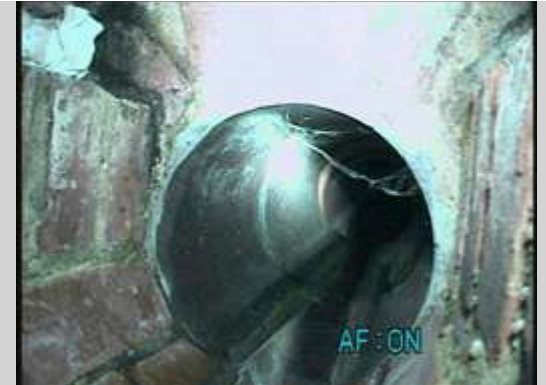
12 O'Clock Outflow

8 in. Circular Gravity Sewer
Pipe Out @ 12 O'Clock

Pipe Material: **Clay** ☐ Pipe Lined

Invert Depth: **10.13** (ft.) Flow Characteristics: **Slow**

Infiltration: **None** Pipe Seal Cond: **Unknown**

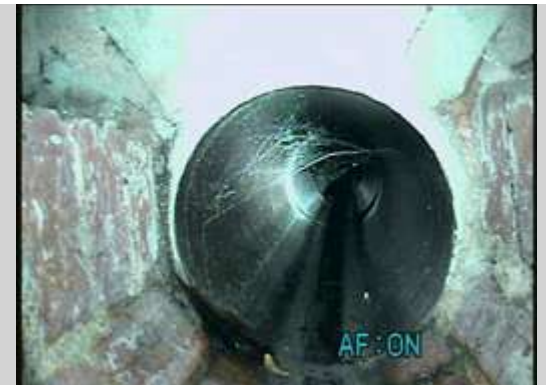
5 O'Clock Inflow

8 in. Circular Gravity Sewer
Pipe In @ 5 O'Clock

Pipe Material: **Clay** ☐ Pipe Lined

Invert Depth: **9.80** (ft.) Flow Characteristics: **None**

Infiltration: **None** Pipe Seal Cond: **Unknown**
